Troubleshooting the Saturn/ 210/220 GC/MS

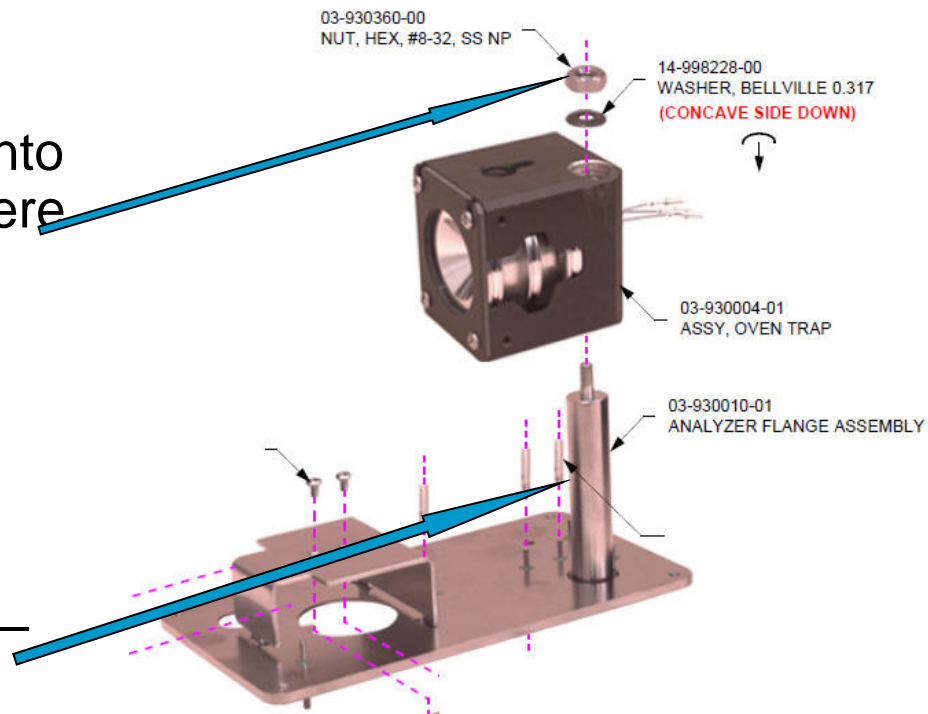
Trap Oven Not heating?

- Make sure the thermocouple and heater are properly installed
- Check the nut holding the plate onto the trap oven – a bad connection here will cause heating problems
- Replace heater
- Try replacing the analyzer flange – the post may have been bent

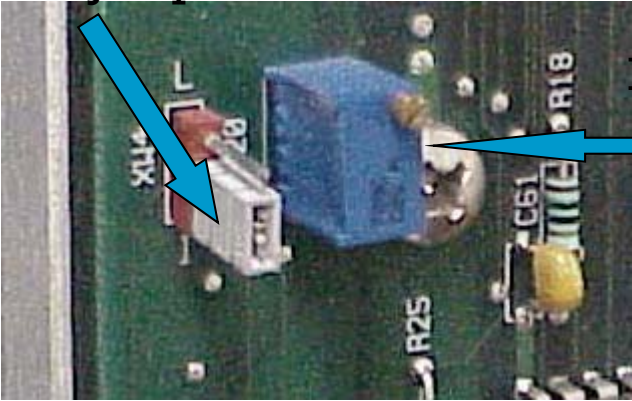
The integrator zero may not be adjusting electronically and may need a manual adjustment.

Check the results in the current module attributes to see if the Integrator zero test was "OK", "High", or "Low". If the results was "High" or "Low", the integrator zero needs a manual adjustment.

Put Jumper in “L” position and adjust R66 until integrator zero value is OK
